**Flood Control Project Maintenance
Levee Inspections**

Fall 2019 Levee Maintenance Deficiency Summary Report

Sacramento River Basin

**Flood Control Project Maintenance
Levee Inspections****LMA District Cover Sheet****Fall 2019 Levee Inspection Results****Reclamation District No. 0003 Grand Island**

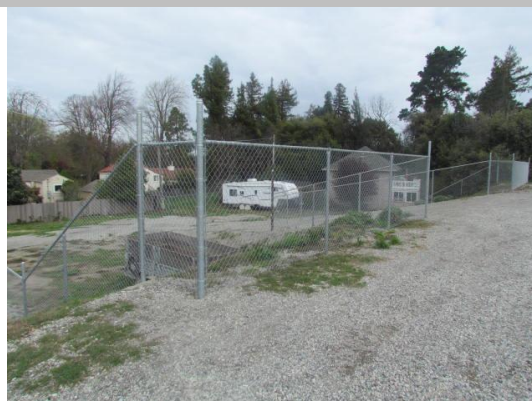
Photo 1 of 1 : FA_2019_RD0003_25_267_20190826_00170.jpg

LM Start	11.99	Rating **	M	Issue No.	267
LM End	11.99	Issue Type +	En	Location *	LS
Category	Earthen Levee			GPS Latitude/Longitude	
				Start	End
Item	Encroachments			38.246025°	38.246025°
				-121.512327°	-121.512327°
DWR ID	DWR_RD0003_02_s_2012_267				
Comment Code					
FE : Fence					
Inspector Comment

Looking north at fence on landside shoulder and slope.

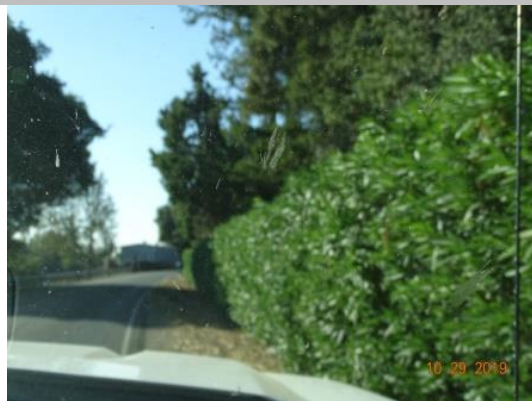
Photo 1 of 1 : FA_2019_RD0003_25_31_20191030_00327.jpg

LM Start	12.01	Rating **	U	Issue No.	31
LM End	12.18	Issue Type +	En	Location *	LS
Category	Earthen Levee			GPS Latitude/Longitude	
				Start	End
Item	Vegetation			38.246310 °	38.248682 °
				-121.512157 °	-121.511657 °
DWR ID	DWR_RD0003_02_s_2012_31				
Comment Code					
V6 : Landscaping					
Inspector Comment

View looking downstream at landscaping on the landside slope (Fall 2019).

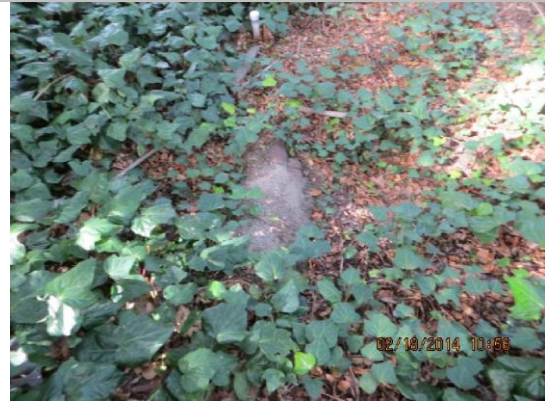
6-inch pipe visible on LS toe.

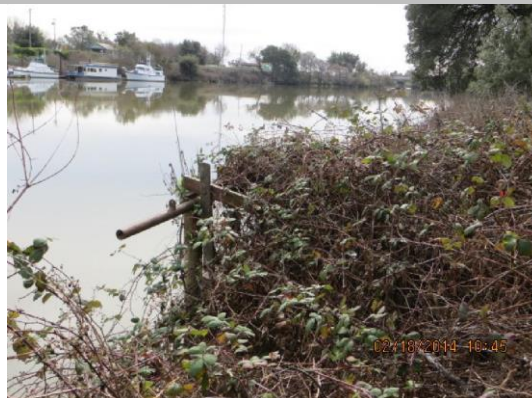
Photo 1 of 3 : UCIP_FA_2019_30305_55725.jpg

Comment Code						
Inspector Comment						
DS_ID:22297						
FS_ID:30305						
EP_NO: N/A						
Repair Type: Non-Urgent						
Crossing Status: Found						
UCIP Comments: Pump and pipe abandoned and should be done so properly.						
FIELD_STRUCT_DESC: 7-inch steel irrigation discharge pipe through the levee, invert elevation 8.4 feet below the crown. Pump platform visible on the waterside (WS) slope. 1.5-inch steel electrical conduit through the levee at the same location. (H. Town). [Additional Reference(s): DWR Levee Log, 1993, 5-inch pipe referenced. USACE Sacramento O&M Manual 104, February 1960, (RM 27.29), 5-inch galvanized iron pipe referenced].						
FS Date: 2/18/2014

Abandoned pump platform on WS slope.

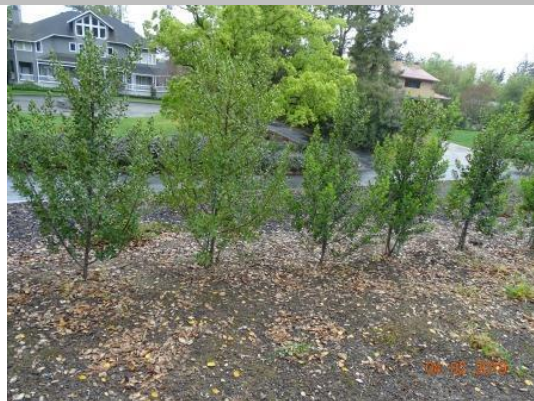
Photo 1 of 2 : FA_2019_RD0003_25_35_20190826_00030.jpg

LM Start	12.38	Rating **	U	Issue No.	35
LM End	12.47	Issue Type +	En	Location *	LS
Category	Earthen Levee			GPS Latitude/Longitude	
				Start	End
Item	Vegetation			38.251463 °	38.252711 °
				-121.512458 °	-121.513214 °
DWR ID	DWR_RD0003_02_s_2012_35				
Comment Code					
V6 : Landscaping					
Inspector Comment					
Remove newly planted trees from the landside.

View of newly planted trees on the landside slope (Spring 2019).

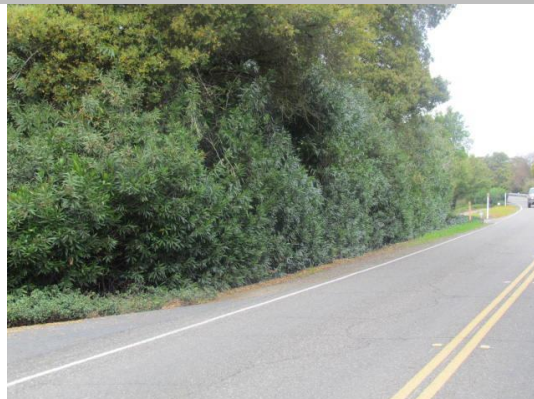
Photo 2 of 2 : FA_2019_RD0003_25_35_20190826_00031.jpg

Looking northwest at dense landscaping on landside shoulder and slope.

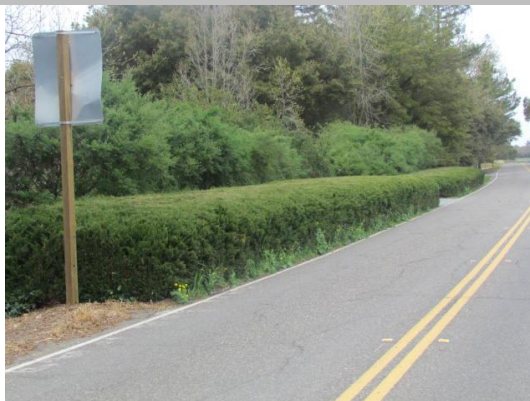
Photo 1 of 1 : FA_2019_RD0003_25_37_20190826_00032.jpg

LM Start	12.54	Rating **	U	Issue No.	37
LM End	12.62	Issue Type +	En	Location *	LS
Category	Earthen Levee			GPS Latitude/Longitude	
				Start	End
Item	Vegetation			38.253593 °	38.254437 °
				-121.513883 °	-121.514708 °
DWR ID	DWR_RD0003_02_s_2012_37				
Comment Code					
V6 : Landscaping					
Inspector Comment					
There is dense landscaping on the landside shoulder and slope.

Looking northwest at dense landscaping on landside shoulder and slope.

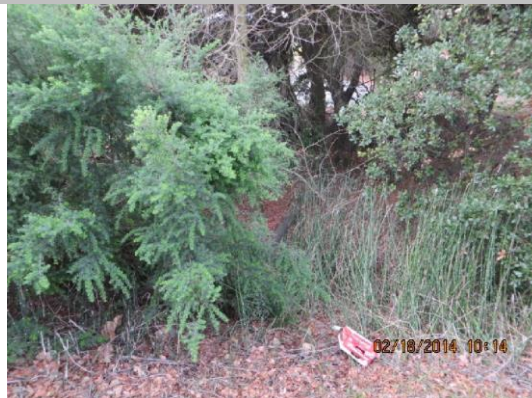
Photo 1 of 3 : UCIP_FA_2019_40544_55694.jpg

Comment Code					
Inspector Comment					
DS_ID:22299 FS_ID:40544 EP_NO: 1376 Repair Type: Non-Urgent Crossing Status: Found UCIP Comments: Pipe abandoned and should be done so properly. Pipe rusted through at various locations. FIELD_STRUCT_DESC: 12-inch steel irrigation discharge pipe through the levee, invert elevation 5 feet below the crown. Pump is missing from the waterside (WS) slope, and a steel plate is bolted over the end of the pipe. 42-inch concrete standpipe at the landside (LS) toe. 1.5-inch steel electrical conduit through the levee at the same location. (Plans for installing a vertical unit irrigation pumping plant and a 12-inch steel discharge pipe through the levee authorized under Permit No. 1376, 1949 - Joseph Gwerder Estate). [Additional Reference(s): DWR Levee Log, 1993. USACE Sacramento O&M Manual 104, February 1960, (RM 27.59)]. FS Date: 2/18/2014

Pipe visible on LS slope.

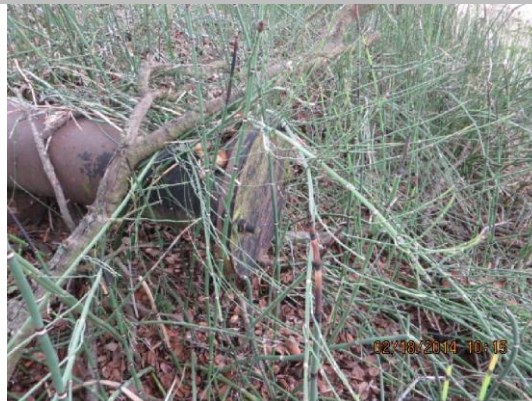
Photo 2 of 3 : UCIP_FA_2019_40544_55693.jpg

Steel plate bolted over pipe end on WS slope.

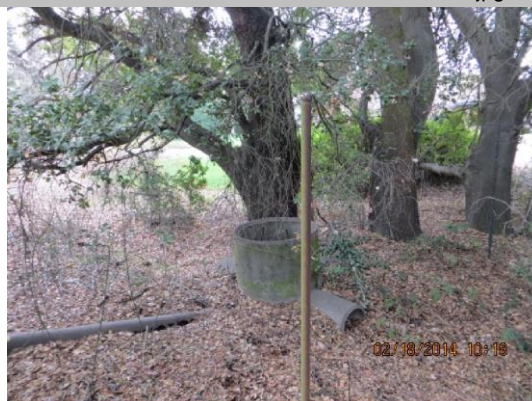
Photo 3 of 3 : UCIP_FA_2019_40544_55692.jpg

Comment Code					
Inspector Comment					
DS_ID:22299 FS_ID:40544 EP_NO: 1376 Repair Type: Non-Urgent Crossing Status: Found UCIP Comments: Pipe abandoned and should be done so properly. Pipe rusted through at various locations. FIELD_STRUCT_DESC: 12-inch steel irrigation discharge pipe through the levee, invert elevation 5 feet below the crown. Pump is missing from the waterside (WS) slope, and a steel plate is bolted over the end of the pipe. 42-inch concrete standpipe at the landside (LS) toe. 1.5-inch steel electrical conduit through the levee at the same location. (Plans for installing a vertical unit irrigation pumping plant and a 12-inch steel discharge pipe through the levee authorized under Permit No. 1376, 1949 - Joseph Gwerder Estate). [Additional Reference(s): DWR Levee Log, 1993. USACE Sacramento O&M Manual 104, February 1960, (RM 27.59)]. FS Date: 2/18/2014

Concrete standpipe on LS toe.

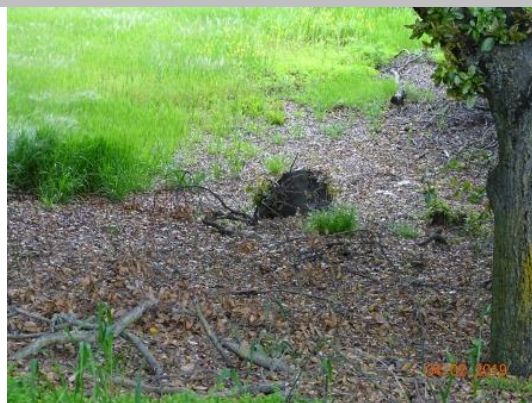
Photo 1 of 1 : FA_2019_RD0003_25_135_20190826_00106.jpg

LM Start	12.88	Rating **	N	Issue No.	135
LM End	12.88	Issue Type +	Ma	Location *	LS
Category	Earthen Levee			GPS Latitude/Longitude	
				Start	End
Item	Trim / Thin Trees			38.257244 °	38.257244 °
				-121.518037 °	-121.518037 °
DWR ID	DWR_RD0003_02_s_2018_135				
Comment Code					
T5 : Tree stumps.					
Inspector Comment					
There is a tree stump at levee toe.

View looking downslope at tree trunk at the bottom of the landside slope (Spring 2019).

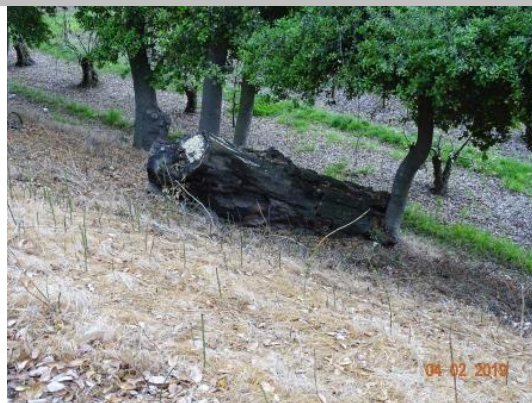
Photo 1 of 1 : FA_2019_RD0003_25_147_20190826_00126.jpg

LM Start	12.97	Rating **	U	Issue No.	147
LM End	12.97	Issue Type +	En	Location *	LS
Category	Earthen Levee			GPS Latitude/Longitude	
				Start	End
Item	Encroachments			38.258108°	38.258108°
				-121.519272°	-121.519272°
DWR ID	DWR_RD0003_02_s_2019_147				
Comment Code					
TR : Tree or limb					
Inspector Comment					
Remove the large log from the landside slope.

View looking downslope at tree trunk on the landside slope (Spring 2019).

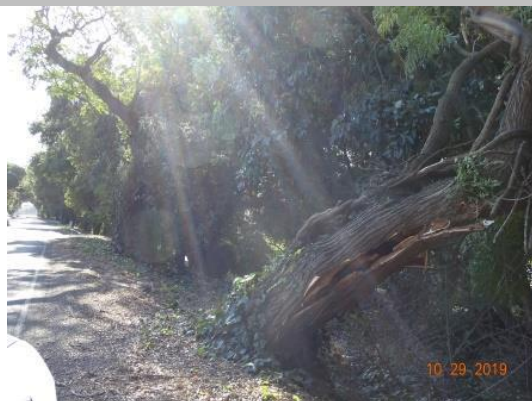
Photo 1 of 1 : FA_2019_RD0003_25_82_20191030_00326.jpg

LM Start	13.03	Rating **	M	Issue No.	82
LM End	13.06	Issue Type +	En	Location *	LS
Category	Earthen Levee			GPS Latitude/Longitude	
				Start	End
Item	Vegetation			38.258703 °	38.259003 °
				-121.520160 °	-121.520557 °
DWR ID	DWR_RD0003_02_s_2012_82				
Comment Code					
V6 : Landscaping					
Inspector Comment

View of looking downstream at landscaping on the landside slope (Fall 2019).

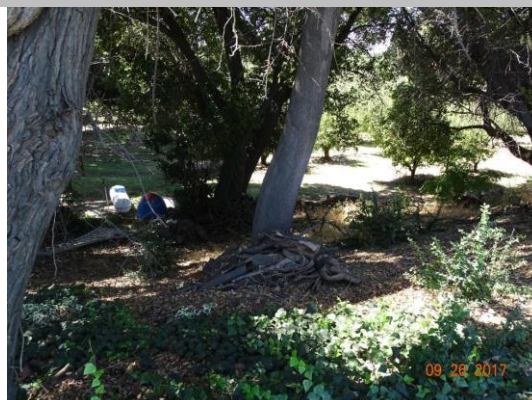
Photo 1 of 1 : FA_2019_RD0003_25_133_20190826_00104.jpg

LM Start	13.06	Rating **	M	Issue No.	133
LM End	13.06	Issue Type +	En	Location *	LS
Category	Earthen Levee			GPS Latitude/Longitude	
				Start	End
Item	Encroachments			38.258962 °	38.258962 °
				-121.520385 °	-121.520385 °
DWR ID	DWR_RD0003_02_s_2017_133				
Comment Code					
PR : Prunings					
Inspector Comment					
Debris and prunings are at the landside toe.

Looking southwest at the landside slope.

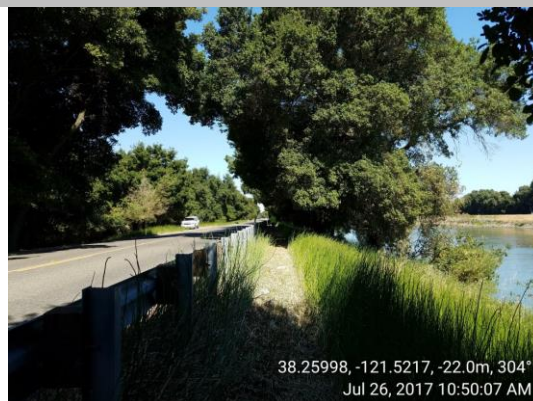
Photo 3 of 3 : FA_2019_RD0003_25_139_20190826_00115.jpg

LM Start	13.15	Rating **	A/W	Issue No.	139 (cont)
LM End	13.17	Issue Type +	Ma	Location *	WS
Category	Supplemental			GPS Latitude/Longitude	
				Start	End
Item	2017 Storm Damage			38.260042°	38.260219°
				-121.521581°	-121.521803°
DWR ID	LMA-107				
Comment Code					
Inspector Comment					
<p>Levee Evaluation Comments</p> <p>Description: District station 694+80 to 695+69, Sec. 27, 1. 5 N. R. 4 E., M.D.M. Approximately 89 linear feet of erosion and sloughing exists along the water side slope of the Sacramento River (Unit 2). The erosion commences approximately 1/2 of the way down the slope from the crown and extends into the rip rap.</p> <p>Site ID No: 281</p> <p>Site Designation: LMA-107</p> <p>Repair Type: Erosion</p> <p>Rating: Area of Concern</p> <p>Field Date: 7/26/2017</p> <p>Notes:</p>

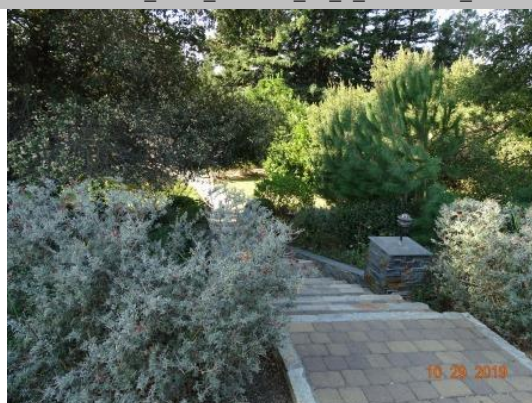
Photo 1 of 1 : FA_2019_RD0003_25_9_20191030_00325.jpg

LM Start	13.36	Rating **	M	Issue No.	9
LM End	13.36	Issue Type +	En	Location *	LS
Category	Earthen Levee			GPS Latitude/Longitude	
				Start	End
Item	Encroachments			38.262125 °	38.262125 °
				-121.524405 °	-121.524405 °
DWR ID	DWR_RD0003_02_s_2012_9				
Comment Code					
ST : Stairway					
Inspector Comment					
Landowner installed unauthorized stairs on the landside slope. There is no permit on record for these stairs.

View of unauthorized stairs on the landside slope (Fall 2019).

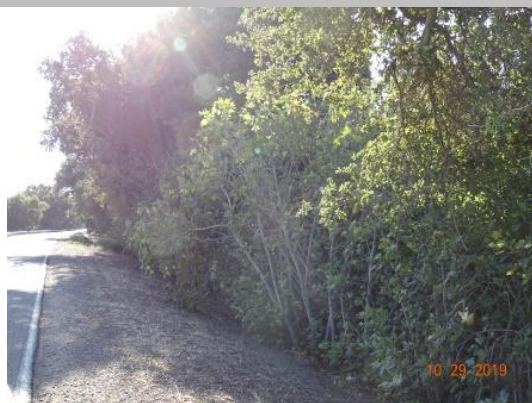
Photo 1 of 1 : FA_2019_RD0003_25_99_20191030_00324.jpg

LM Start	13.40	Rating **	U	Issue No.	99
LM End	13.40	Issue Type +	En	Location *	LS
Category	Earthen Levee			GPS Latitude/Longitude	
				Start	End
Item	Vegetation			38.262449 °	38.262449 °
				-121.524899 °	-121.524899 °
DWR ID	DWR_RD0003_02_f_2015_99				
Comment Code					
V6 : Landscaping					
Inspector Comment					
Figs trees and other plants are blocking the view of the landside slope.

View looking downstream at landscaping on the landside slope (Fall 2019).

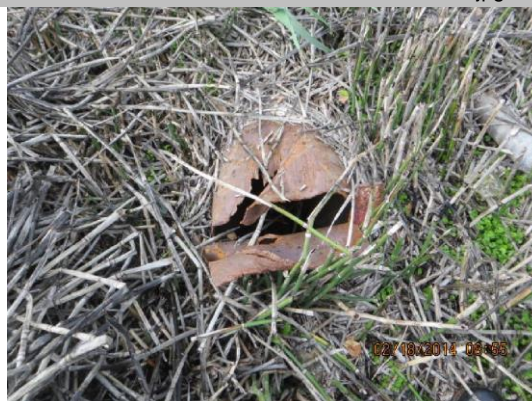
Photo 2 of 3 : UCIP_FA_2019_41585_55627.jpg

LM Start	13.70	Rating **	M	Issue No.	993 (cont)	
LM End	13.70	Issue Type +	En	Location *		
Category	Supplemental			GPS Latitude/Longitude		
				Start	End	
Item	DRAFT DWR UCIP Field Study			38.265474 °	38.265474 °	
				-121.528819 °	-121.528819 °	
DWR ID	22306					
Comment Code						
Inspector Comment						
DS_ID:22306						
FS_ID:41585						
EP_NO: N/A						
Repair Type: Non-Urgent						
Crossing Status: Found						
UCIP Comments: Steel plate broken and pipe open on WS slope. Pipe abandoned and should be done so properly.						
FIELD_STRUCT_DESC: *ABANDONED* 12-inch steel irrigation pipe through the levee, 6 feet below the crown. (Steel plate welded on the waterside [WS] end by USACE, Unit 15, in 1969). [Additional Reference(s): DWR Levee Log, 1993].						
FS Date: 2/18/2014

Pipe open on WS slope.

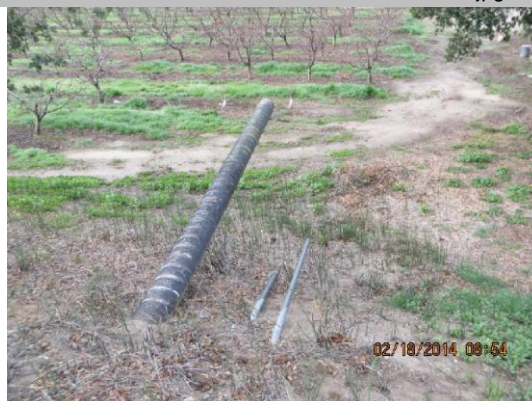
Photo 1 of 3 : UCIP_FA_2019_30204_55605.jpg

LM Start	13.70	Rating **	M	Issue No.	994	
LM End	13.70	Issue Type +	En	Location *		
Category	Supplemental			GPS Latitude/Longitude		
				Start	End	
Item	DRAFT DWR UCIP Field Study			38.265479 °	38.265479 °	
				-121.528825 °	-121.528825 °	
DWR ID	22307					
Comment Code						
Inspector Comment						
DS_ID:22307						
FS_ID:30204						
EP_NO: N/A						
Repair Type: Non-Urgent						
Crossing Status: Found						
UCIP Comments: Abandoned and should be done so properly as it is open on both ends.						
FIELD_STRUCT_DESC: *ABANDONED* 2-inch electrical conduit of an unknown material through the levee, 5.5 feet below the crown. (Open on both ends by USACE, Unit 15, in 1969). [Additional Reference(s): DWR Levee Log, 1993].						
FS Date: 2/18/2014

Pipe visible at right on LS slope.

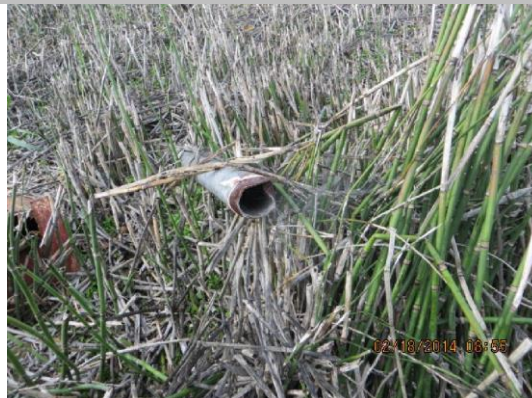
Photo 3 of 3 : UCIP_FA_2019_30204_55603.jpg

LM Start	13.70	Rating **	M	Issue No.	994 (cont)	
LM End	13.70	Issue Type +	En	Location *		
Category	Supplemental			GPS Latitude/Longitude		
				Start	End	
Item	DRAFT DWR UCIP Field Study			38.265479 °	38.265479 °	
				-121.528825 °	-121.528825 °	
DWR ID	22307					
Comment Code						
Inspector Comment						
DS_ID:22307						
FS_ID:30204						
EP_NO: N/A						
Repair Type: Non-Urgent						
Crossing Status: Found						
UCIP Comments: Abandoned and should be done so properly as it is open on both ends.						
FIELD_STRUCT_DESC: *ABANDONED* 2-inch electrical conduit of an unknown material through the levee, 5.5 feet below the crown. (Open on both ends by USACE, Unit 15, in 1969). [Additional Reference(s): DWR Levee Log, 1993].						
FS Date: 2/18/2014

Pipe open on both ends.

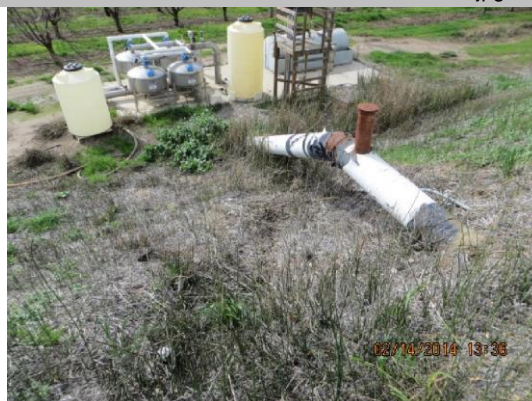
Photo 2 of 3 : UCIP_FA_2019_30203_55601.jpg

Item	DRAFT DWR UCIP Field Study			38.267355 °		38.267355 °
				-121.531262 °		-121.531262 °
DWR ID	22308					
Comment Code						
Inspector Comment						
DS_ID:22308 FS_ID:30203 EP_NO: N/A Repair Type: Non-Urgent Crossing Status: Found UCIP Comments: Erosion next to pipe on LS slope. FIELD_STRUCT_DESC: 16-inch steel irrigation discharge pipe through the levee, 3 feet below the crown. 14-inch pipe sleeved through the 16-inch pipe and a 1.5-inch steel electrical conduit at the same location. Slant pump on the waterside (WS) slope and a filter plant at the landside (LS) toe. [Additional Reference(s): DWR Levee Log, 1993, referenced as 5.6 feet below the crown. USACE Sacramento O&M Manual 104, February 1960, (RM 28.91), referenced as invert elevation 5.6 feet below the crown]. FS Date: 2/14/2014

Erosion in foreground with pipe and filter plant in background.

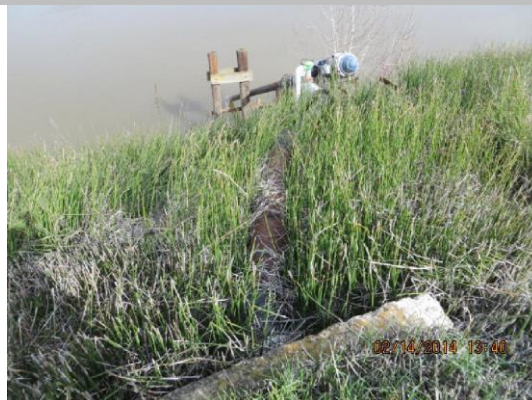
Photo 3 of 3 : UCIP_FA_2019_30203_55600.jpg

Concrete headwall, pipe, and slantpump on WS slope.

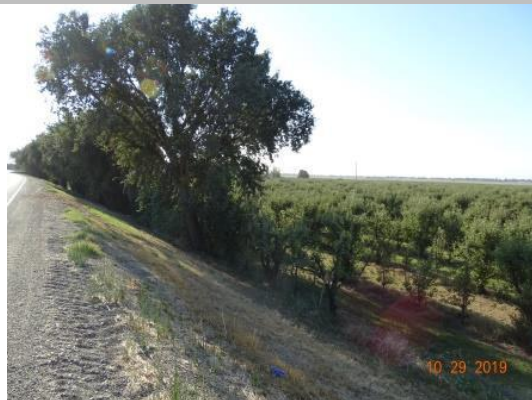
Photo 1 of 1 : FA_2019_RD0003_25_207_20191030_00323.jpg

LM Start	14.31	Rating **	M	Issue No.	207
LM End	14.68	Issue Type +	En	Location *	LS
Category	Earthen Levee			GPS Latitude/Longitude	
				Start	End
Item	Encroachments			38.271512 °	38.275220 °
				-121.537067 °	-121.541953 °
DWR ID	DWR_RD0003_02_f_2019_207				
Comment Code					
CR : Crops					
Inspector Comment					
Pear trees at landside toe.

View looking downstream of pear trees at the landside toe (Fall 2019).

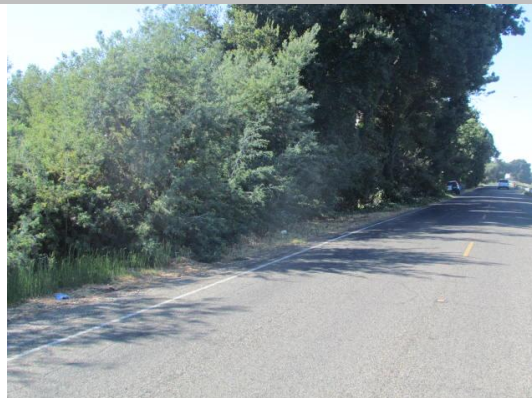
Photo 1 of 2 : FA_2019_RD0003_25_72_20190826_00047.jpg

LM Start	14.68	Rating **	U	Issue No.	72
LM End	14.84	Issue Type +	En	Location *	LS
Category	Earthen Levee			GPS Latitude/Longitude	
				Start	End
Item	Vegetation			38.275217 °	38.276857 °
				-121.541953 °	-121.543988 °
DWR ID	DWR_RD0003_02_s_2012_72				
Comment Code					
V6 : Landscaping					
Inspector Comment

Looking westly at dense landscaping on landward shoulder and slope.

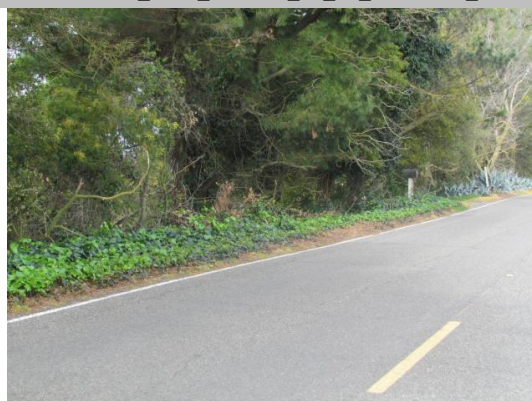
Photo 2 of 2 : FA_2019_RD0003_25_72_20190826_00048.jpg

Looking northwest at dense landscaping on landside shoulder and slope.

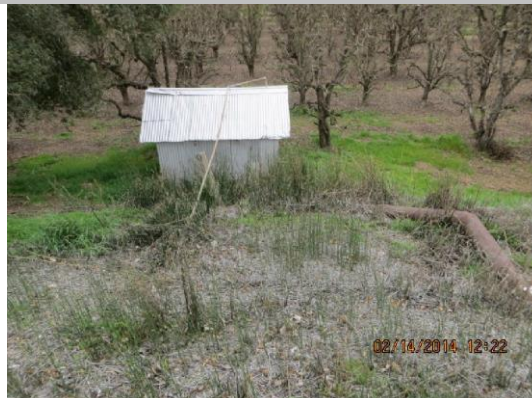
Photo 1 of 3 : UCIP_FA_2019_30164_55565.jpg

Comment Code						
Inspector Comment						
DS_ID:22370 FS_ID:30164 EP_NO: N/A Repair Type: Non-Urgent Crossing Status: Indicator Found UCIP Comments: Pipe abandoned and should be verified as having been done so properly. FIELD_STRUCT_DESC: *ABANDONED* 7-inch steel pipe of an unknown purpose through the levee, invert elevation 4.6 feet below the crown. (Green). 1.5-inch electrical conduit through the levee at the same location. Depression in-line with pump house on the waterside (WS) is a good indicator of the pipe location. 36-inch concrete standpipe at the landside (LS) toe. [DWR Levee Log, 1993. USACE Sacramento O&M Manual 104, February 1960, (RM 29.94)]. FS Date: 2/14/2014

Pumphouse on LS toe good indicator of abandoned pipe location.

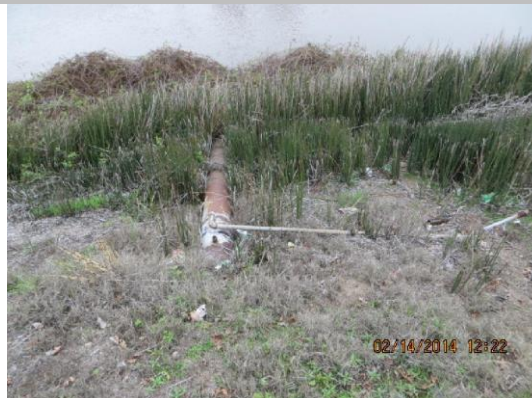
Photo 2 of 3 : UCIP_FA_2019_30165_55567.jpg

Item	DRAFT DWR UCIP Field Study			38.277631 °	38.277631 °	
				-121.544718 °	-121.544718 °	
DWR ID	22369					
Comment Code						
Inspector Comment						
DS_ID:22369 FS_ID:30165 EP_NO: 919 Repair Type: Non-Urgent Crossing Status: Found UCIP Comments: Appears abandoned and if so should be done so properly. FIELD_STRUCT_DESC: 10-inch steel irrigation discharge pipe through the levee, invert elevation 3.8 feet below the crown. Pump and gate valve in a pump house at the landside (LS) toe. 2-inch filler pipe at the same location, 3 feet below the crown. (Plans for the installation of a 10-inch, 7-gauge welded steel pipe through the levee authorized under Permit No. 919, 1943 - Dell Kercheval). [Additional Reference(s): DWR Levee Log, 1993. USACE Sacramento O&M Manual 104, February 1960 (RM 29.94)]. FS Date: 2/14/2014

Pipe visible on WS slope and filler pipe visible.

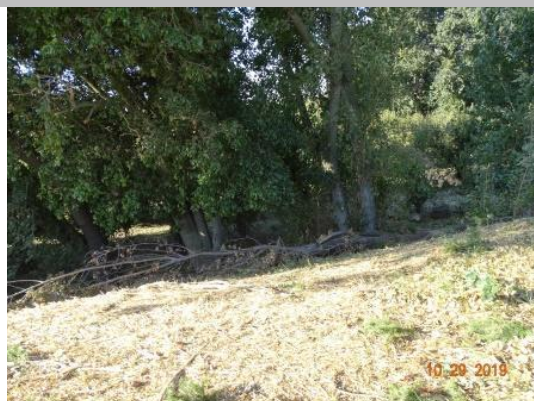
Photo 1 of 1 : FA_2019_RD0003_25_206_20191030_00321.jpg

LM Start	14.96	Rating **	M	Issue No.	206
LM End	14.96	Issue Type +	En	Location *	LS
Category	Earthen Levee			GPS Latitude/Longitude	
				Start	End
Item	Encroachments			38.278155 °	38.278155 °
				-121.545397 °	-121.545397 °
DWR ID	DWR_RD0003_02_f_2019_206				
Comment Code					
TR : Tree or limb					
Inspector Comment

View of fallen tree at the bottom of the landside slope (Fall 2019).

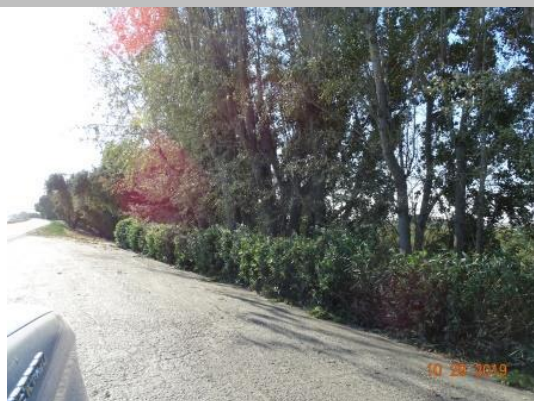
Photo 1 of 1 : FA_2019_RD0003_25_53_20191030_00320.jpg

LM Start	14.96	Rating **	U	Issue No.	53
LM End	14.98	Issue Type +	En	Location *	LS
Category	Earthen Levee			GPS Latitude/Longitude	
				Start	End
Item	Vegetation			38.278237°	38.278395°
				-121.545405°	-121.545613°
DWR ID	DWR_RD0003_02_f_2019_53				
Comment Code					
V6 : Landscaping					
Inspector Comment

View looking downstream at landscaping at the top of the landside slope (Fall 2019).

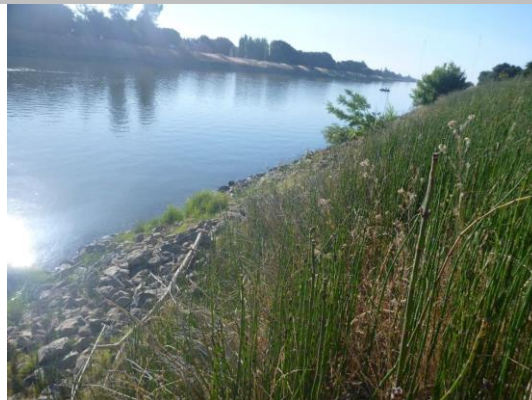
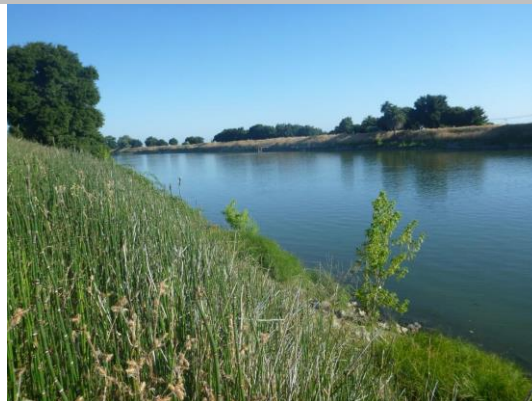
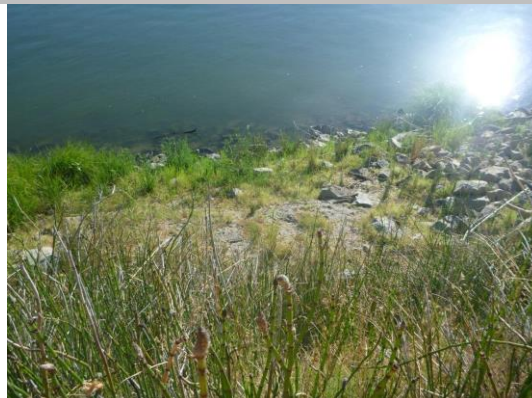
LM Start	15.00	Rating **	A/W	Issue No.	142
LM End	15.07	Issue Type +	Ma	Location *	WS
Category	Supplemental		GPS Latitude/Longitude		
			Start	End	
Item	2017 Storm Damage		38.278806°	38.279444°	
			-121.545817°	-121.546647°

LM Start	15.00	Rating **	A/W	Issue No.	142 (cont)	
LM End	15.07	Issue Type +	Ma	Location *	WS	
Category	Supplemental			GPS Latitude/Longitude		
				Start	End	
Item	2017 Storm Damage			38.278806 °	38.279444 °	
				-121.545817 °	-121.546647 °	
DWR ID	LMA-108					
Comment Code						
Inspector Comment						
Levee Evaluation Comments						
Description: District station 792+44 to 795+74, Sec. 16, T. 5 N. R. 4 E., M.D.M. Approximately 330 linear feet of erosion and sloughing exists along the water side slope of the Sacramento River (Unit 2). The erosion commences approximately 1/2 of the way down the slope from the crown and extends into the rip rap.						
Site ID No: 282						
Site Designation: LMA-108						
Repair Type: Erosion						
Rating: Area of Concern						
Field Date: 7/28/2017						
Notes: no berm

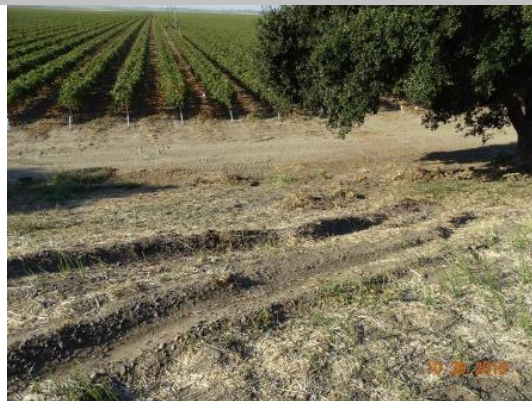
Photo 1 of 1 : FA_2019_RD0003_25_191_20191030_00319.jpg

LM Start	15.17	Rating **	M	Issue No.	191
LM End	15.17	Issue Type +	Ma	Location *	LS
Category	Earthen Levee		GPS Latitude/Longitude		
			Start	End	
Item	Slope Stability		38.280443°	38.280443°	
			-121.548175°	-121.548175°	
DWR ID	DWR_RD0003_02_f_2019_191				
Comment Code					
S3 : Repair the levee slope damaged by vehicle traffic and prevent access where possible.					
Inspector Comment					
Fresh vehicle tracks on the landside slope.

View of fresh vehicle tracks going down the landside slope (Fall 2019).

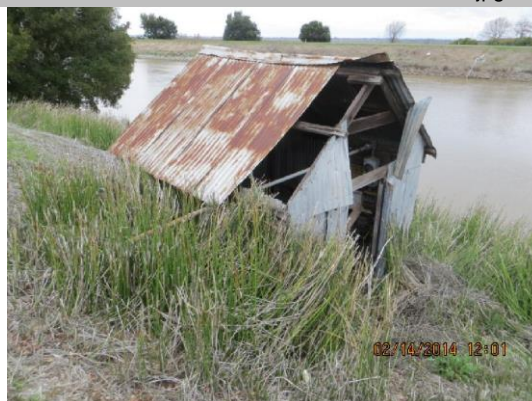
Photo 2 of 3 : UCIP_FA_2019_53292_55541.jpg

DS_ID:22371
FS_ID:53292
EP_NO: N/A
Repair Type: Urgent
Crossing Status: Found
UCIP Comments: 07/20/2018 Everything appears to be the same as last time. No changes have been made. No new pipe has been put in. Crossing remains "Urgent" because of the holes visible in 2014. (DWR UCIP - A. McDonald)07/06/2016 Heavy vegetation prevented visibility. Per RD0003 president David Robertson, WS erosion repaired last Spring. Could not fully see any repair work done. Need to return when vegetation cleared. Appears abandoned and if so should be done properly. (DWR UCIP - K. Fazel)02/14/2014 Pipe rusted through on WS slope. Appears abandoned and should be done so properly. Erosion of WS slope under pipe on WS toe. (DWR FPIIB - G. Wylie) FIELD_STRUCT_DESC: *ABANDONED* 12-inch steel irrigation discharge pipe through the levee, invert elevation 7 feet below the crown. Slant pump next to old pump house on the waterside (WS) slope. 2-inch filler pipe at the same location. 4-foot by 8-foot concrete distribution box and standpipe at the landside (LS) toe. (Plans to replace a 12-inch steel pipe through the levee authorized under Permit No. 7082, 1974 - Pacific Fruit Farms). Permit was canceled. Original pipe remains. [Additional Reference(s): DWR Levee Log, 1993. USACE Sacramento O&M Manual 104, February 1960, (RM 30.30)]. FS Date: 7/20/2018

Pumphouse on WS slope next to slant pump.

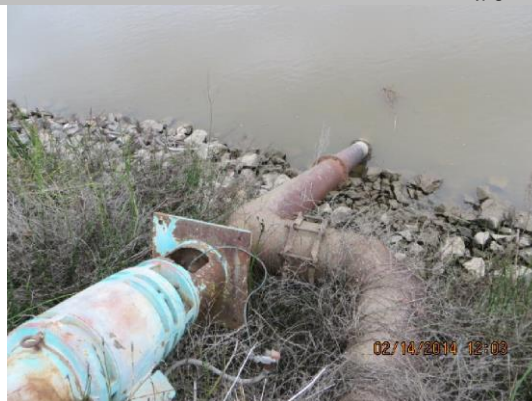
Photo 3 of 3 : UCIP_FA_2019_53292_55540.jpg

Slant pump on WS slope.

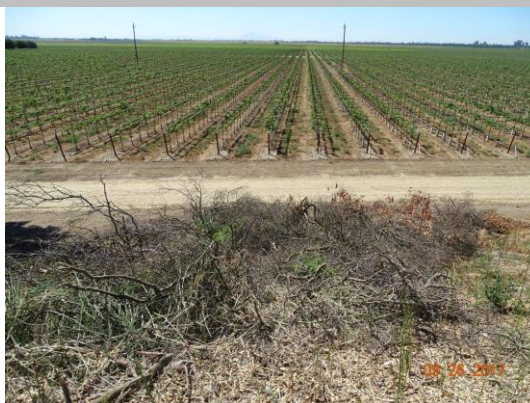
Photo 1 of 1 : FA_2019_RD0003_25_134_20190826_00105.jpg

LM Start	15.37	Rating **	M	Issue No.	134
LM End	15.37	Issue Type +	En	Location *	LS
Category	Earthen Levee			GPS Latitude/Longitude	
				Start	End
Item	Encroachments			38.282243 °	38.282243 °
				-121.550917 °	-121.550917 °
DWR ID	DWR_RD0003_02_s_2017_134				
Comment Code					
PR : Prunings					
Inspector Comment					
Remove prunings from the landside slope.

Looking southwest at the landside slope.

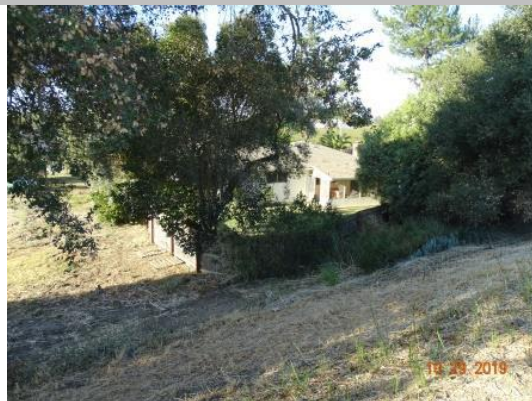
Photo 1 of 1 : FA_2019_RD0003_25_159_20191030_00318.jpg

LM Start	15.45	Rating **	M	Issue No.	159
LM End	15.45	Issue Type +	En	Location *	LS
Category	Earthen Levee			GPS Latitude/Longitude	
				Start	End
Item	Encroachments			38.282940 °	38.282940 °
				-121.552250 °	-121.552250 °
DWR ID	DWR_RD0003_02_f_2019_159				
Comment Code					
FE : Fence					
Inspector Comment					
There is fence located within 10 feet of the toe.

View of wooden fence at the landside toe (Fall 2019).

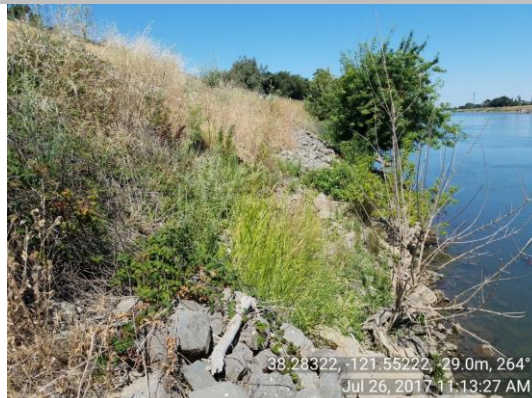
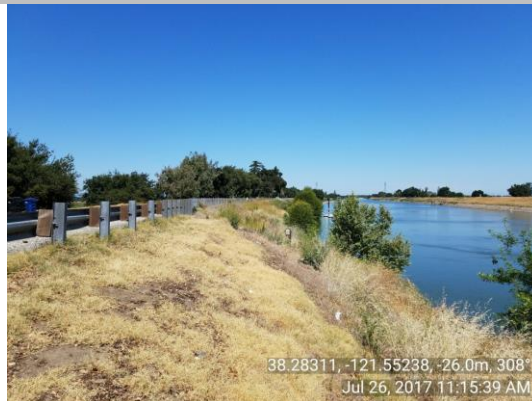
Photo 1 of 3 : FA_2019_RD0003_25_149_20190826_00128.jpg

LM Start	15.46	Rating **	A/W	Issue No.	149 (cont)
LM End	15.47	Issue Type +	Ma	Location *	WS
Category	Supplemental			GPS Latitude/Longitude	
				Start	End
Item	2017 Storm Damage			38.283119 °	38.283172 °
				-121.552250 °	-121.552347 °
DWR ID	LMA-109				
Comment Code					
Inspector Comment					
Levee Evaluation Comments					
Description:District station 816+64 to 816+97, Sec. 16, T. 5 N. R. 4 E., M.D.M. Approximately 33 linear feet of erosion exists along the water side slope of the Sacramento River (Unit 2). The erosion commences approximately 1/2 ofthe way down the slope from the crown and extends into the rip rap. A section of rip rap has eroded away in this location.					
Site ID No:283					
Site Designation:LMA-109					
Repair Type: Erosion					
Rating:Area of Concern					
Field Date:7/26/2017					
Notes:

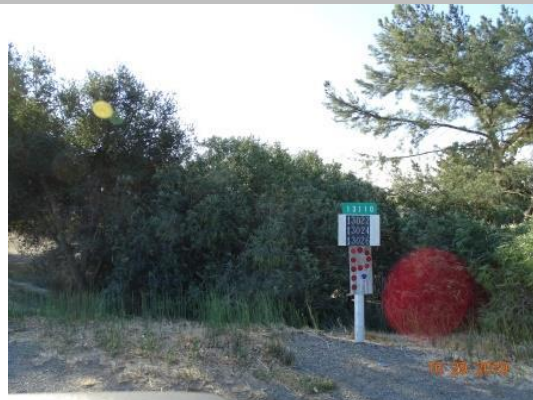
Photo 1 of 1 : FA_2019_RD0003_25_94_20191030_00317.jpg

LM Start	15.47	Rating **	U	Issue No.	94
LM End	15.47	Issue Type +	En	Location *	LS
Category	Earthen Levee			GPS Latitude/Longitude	
				Start	End
Item	Vegetation			38.283050°	38.283050°
				-121.552506°	-121.552506°
DWR ID	DWR_RD0003_02_s_2013_94				
Comment Code					
V6 : Landscaping					
Inspector Comment

View looking downstream at landscaping on the landside slope (Fall 2019).

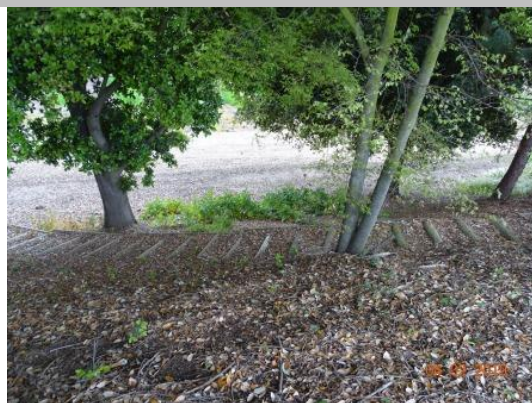
Photo 1 of 1 : FA_2019_RD0003_25_117_20190826_00085.jpg

LM Start	15.56	Rating **	M	Issue No.	117
LM End	15.56	Issue Type +	En	Location *	LS
Category	Earthen Levee			GPS Latitude/Longitude	
				Start	End
Item	Encroachments			38.283910 °	38.283910 °
				-121.553807 °	-121.553807 °
DWR ID	DWR_RD0003_02_s_2019_117				
Comment Code					
ST : Stairway					
Inspector Comment					
There is a stairway on the slope.

View looking downslope at stairway on the landside slope (Spring 2019).

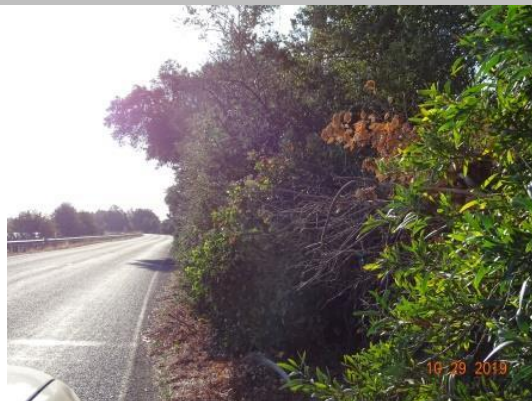
Photo 1 of 1 : FA_2019_RD0003_25_79_20191030_00315.jpg

LM Start	15.58	Rating **	U	Issue No.	79
LM End	15.68	Issue Type +	En	Location *	LS
Category	Earthen Levee			GPS Latitude/Longitude	
				Start	End
Item	Vegetation			38.284124 °	38.285129 °
				-121.554084 °	-121.555342 °
DWR ID	DWR_RD0003_02_s_2012_79				
Comment Code					
V6 : Landscaping					
Inspector Comment

View looking downstream at landscaping on the landside slope (Fall 2019).

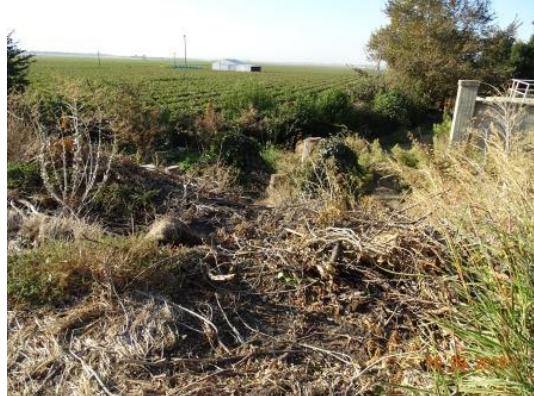
Photo 1 of 1 : FA_2019_RD0003_25_144_20191030_00316.jpg

LM Start	15.61	Rating **	M	Issue No.	144
LM End	15.61	Issue Type +	En	Location *	LS
Category	Earthen Levee			GPS Latitude/Longitude	
				Start	End
Item	Encroachments			38.284393 °	38.284393 °
				-121.554319 °	-121.554319 °
DWR ID	DWR_RD0003_02_f_2015_144				
Comment Code					
PR : Prunings					
Inspector Comment					
Prunings piled on the landside slope and toe along with tree stumps.

View of large prunings pile on the landside slope (Fall 2019).

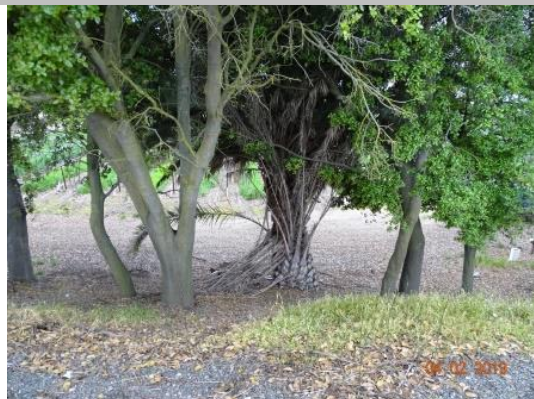
Photo 1 of 1 : FA_2019_RD0003_25_116_20190826_00084.jpg

LM Start	15.70	Rating **	M	Issue No.	116
LM End	15.70	Issue Type +	Ma	Location *	LS
Category	Earthen Levee			GPS Latitude/Longitude	
				Start	End
Item	Trim / Thin Trees			38.285349 °	38.285349 °
				-121.555548 °	-121.555548 °
DWR ID	DWR_RD0003_02_s_2019_116				
Comment Code					
T1 : Trim trees to at least five feet above ground level.					
Inspector Comment					
Remove fallen palm tree limbs.

View looking downslope at fallen palm limbs at the bottom of the landside slope (Spring 2019).

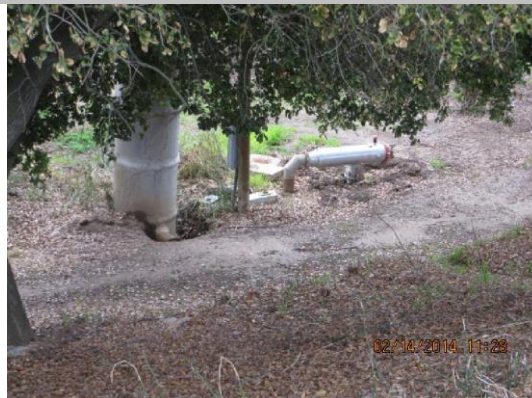
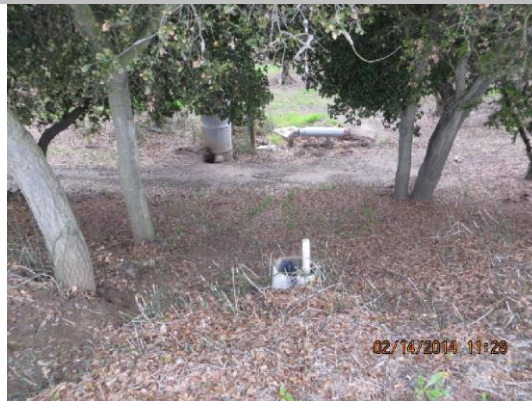
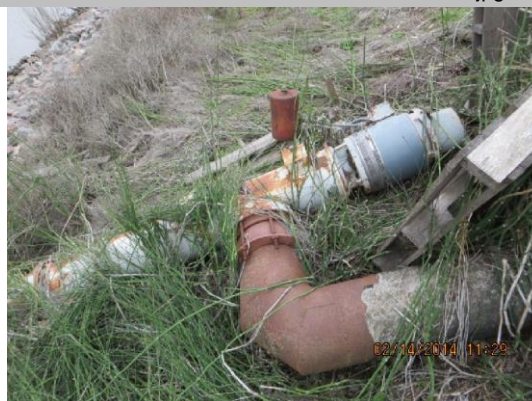
Photo 1 of 3 : UCIP_FA_2019_30084_55485.jpg

Comment Code						
Inspector Comment						
DS_ID:22334						
FS_ID:30084						
EP_NO: 2137						
Repair Type: Non-Urgent						
Crossing Status: Found						
UCIP Comments: Appears abandoned and if so should be done so properly. Leak apparent at pipe connection to concrete standpipe at LS toe. Good candidate for video inspection.						
FIELD_STRUCT_DESC: 12-inch steel irrigation discharge pipe through the levee, invert elevation 9 feet below the crown. Slant pump on the waterside (WS) slope. 44-inch concrete standpipe at the landside (LS) toe. 1.5-inch electrical conduit through the levee at the same location. Filter plant at the LS toe. (Plans for the installation of a 12-inch irrigation pipe through the levee authorized under Permit No. 2137, 1955 - Pacific Fruit Exchange). [Additional Reference(s): DWR Levee Log, 1993, 14-inch pipe referenced, 6.5 feet below the crown. USACE Sacramento O&M Manual 104, February 1960, (RM 30.76)].

Concrete standpipe, filter plant, power pole and meter on LS toe.

Siphon breaker on LS shoulder.

Slant pump on WS slope.

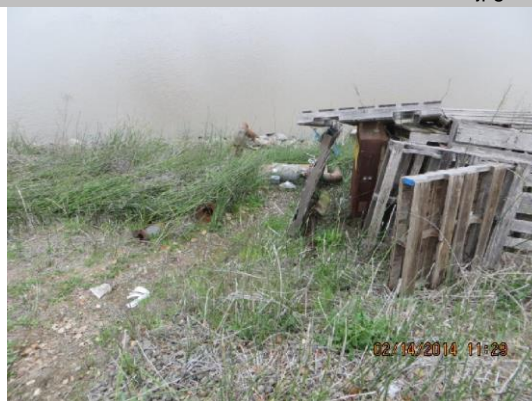
Photo 1 of 3 : UCIP_FA_2019_30083_55482.jpg

Comment Code						
Inspector Comment						
DS_ID:22375						
FS_ID:30083						
EP_NO: 7356						
Repair Type: Non-Urgent						
Crossing Status: Found						
UCIP Comments: Pipe debris on WS slope.						
FIELD_STRUCT_DESC: 10-inch steel irrigation discharge pipe through the levee, 6.5 feet below the crown. 8-inch pipe on the landside (LS) slope. 6-inch pipe on the waterside (WS) slope. Pump and gate valve on the WS slope. (Plans to install a 6-inch pipe and pump on the WS slope of the levee authorized under Permit No. 7356, 1971 - Pacific Fruit Farms. USACE, Unit No. 15, 1969). [Additional Reference(s): DWR Levee Log, 1993].						
FS Date: 2/14/2014

Pump on WS slope next to slant pump.

Vent or Siphon Breaker in 14-inch steel riser on LS slope.

Pipe and filter plant on LS toe.

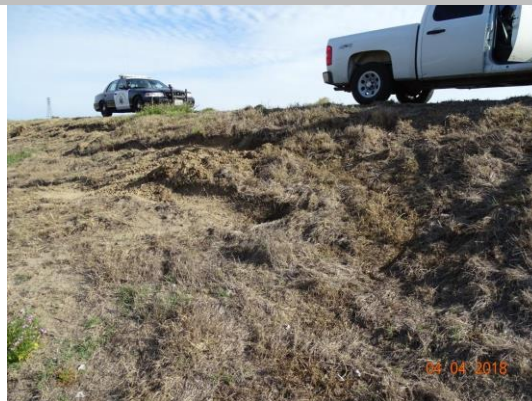
Photo 1 of 1 : FA_2019_RD0003_25_124_20190826_00092.jpg

LM Start	15.94	Rating **	M	Issue No.	124							
LM End	15.94	Issue Type +	Ma	Location *	LS							
Category	Earthen Levee		GPS Latitude/Longitude									
			Start	End								
Item	Slope Stability		38.288009 °	38.288009 °								
			-121.558398 °	-121.558398 °								
DWR ID	DWR_RD0003_02_s_2018_124											
Comment Code												
S3 : Repair the levee slope damaged by vehicle traffic and prevent access where possible.												
Inspector Comment												
There is vehicle erosion on the landside slope.

Vehicle erosion on landside slope should be repaired.

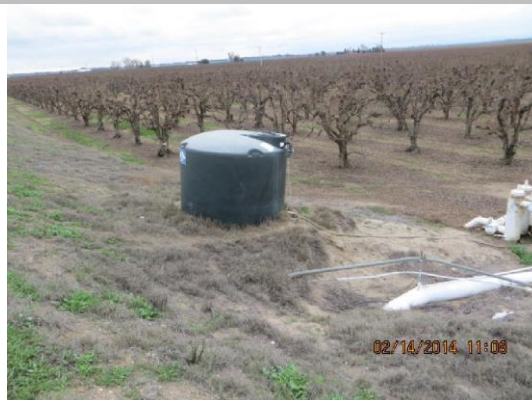
Photo 1 of 3 : UCIP_FA_2019_30004_55382.jpg

Comment Code					
Inspector Comment					
DS_ID:22376 FS_ID:30004 EP_NO: 17382 Repair Type: Non-Urgent Crossing Status: Found UCIP Comments: Tank on LS slope not listed in permit. FIELD_STRUCT_DESC: 12-inch steel irrigation discharge pipe through the levee, 10 feet below the crown. Pump and butterfly valve in a pump house at the landside (LS) toe. Siphon breaker on the waterside (WS) slope. Tank on the LS slope. (Plans to abandon in place two existing deteriorated pipes and install a 12-inch steel irrigation pipe and a 2-inch steel irrigation pipe through the crown and on the slopes of the levee authorized under Permit No. 17382, 2001 - Ferreira Estate Company, DCC Engineering Company, Inc). [Additional Reference(s): DWR Levee Log, 1993, referenced as 5.2 feet below the crown]. FS Date: 2/14/2014

Pump in pumphouse on LS toe.

Tank on LS slope not noted in permit.

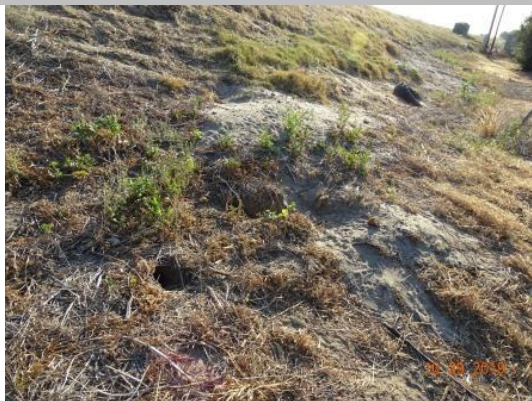
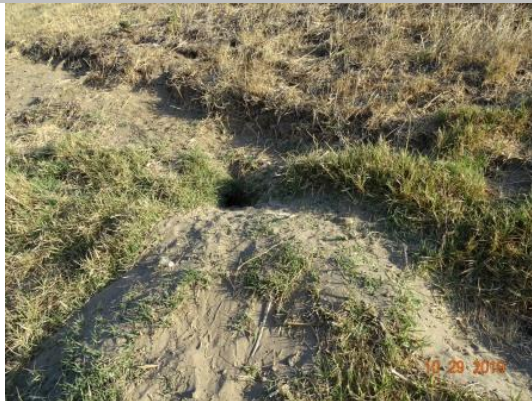
Photo 1 of 3 : FA_2019_RD0003_25_119_20191030_00312.jpg

LM Start	16.07	Rating **	U	Issue No.	119
LM End	16.07	Issue Type +	Ma	Location *	LS
Category	Earthen Levee			GPS Latitude/Longitude	
				Start	End
Item	Animal Control			38.289377 °	38.289377 °
				-121.560002 °	-121.560002 °
DWR ID	DWR_RD0003_02_f_2019_119				
Comment Code					
A1 : Exterminate rodents and backfill and compact or grout burrows.					
Inspector Comment					
There are many fresh rodent holes in landside slope.

View looking downstream at fresh rodent holes in landside slope (Fall 2019).

View of large rodent hole in landside slope (Fall 2019).

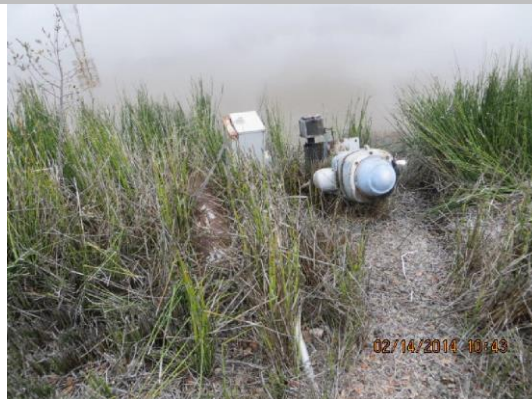
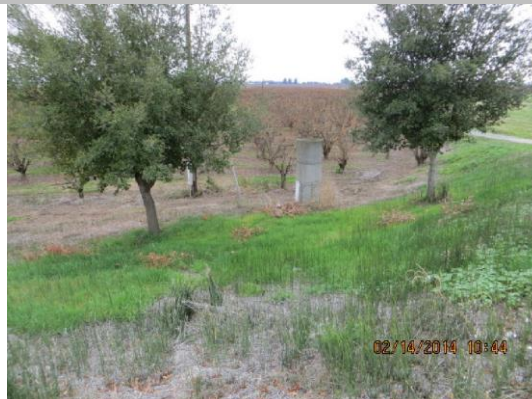
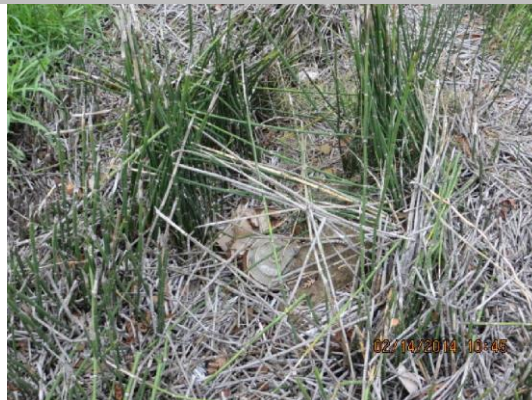
Photo 1 of 3 : UCIP_FA_2019_29986_55369.jpg

Comment Code						
Inspector Comment						
DS_ID:22378						
FS_ID:29986						
EP_NO: N/A						
Repair Type: Non-Urgent						
Crossing Status: Found						
UCIP Comments: siphon breaker on LS slope should have CMP riser protection.						
FIELD_STRUCT_DESC: 16-inch steel irrigation discharge pipe through the levee, 8 feet below the crown. Slant pump on the waterside (WS) slope. Siphon breaker on the landside (LS) slope. 44-inch concrete standpipe at the LS toe. 2-inch aluminum electrical conduit through the levee at the same location as the pipe. (T. Ferreira. USACE Unit No. 6, 1967). [Additional Reference(s): DWR Levee Log, 1993, referenced as 15 feet below the crown. USACE Sacramento O&M Manual 104, February 1960, (RM 31.39), 12-inch pipe, invert elevation 15 feet below the crown, referenced].						
FS Date: 2/14/2014

Slant pump and electrical conduit on WS slope.

44-inch concrete standpipe on LS toe.

Siphon breaker on LS slope

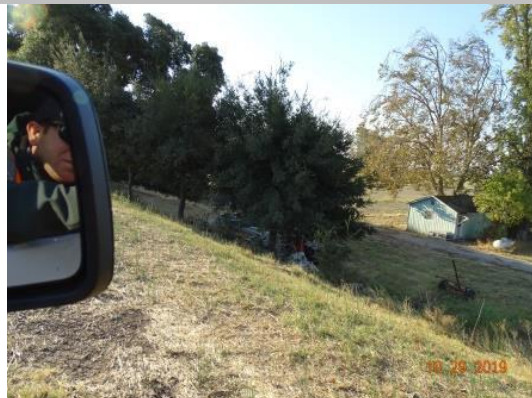
Photo 1 of 1 : FA_2019_RD0003_25_166_20191030_00309.jpg

LM Start	16.54	Rating **	M	Issue No.	166
LM End	16.54	Issue Type +	En	Location *	LS
Category	Earthen Levee			GPS Latitude/Longitude	
				Start	End
Item	Encroachments			38.294600 °	38.294600 °
				-121.565592 °	-121.565592 °
DWR ID	DWR_RD0003_02_f_2017_166				
Comment Code					
GA : Garbage					
Inspector Comment					
Landowner has old junk stored at toe of landside slope.

View looking downstream at garbage at the landside toe (Fall 2019).

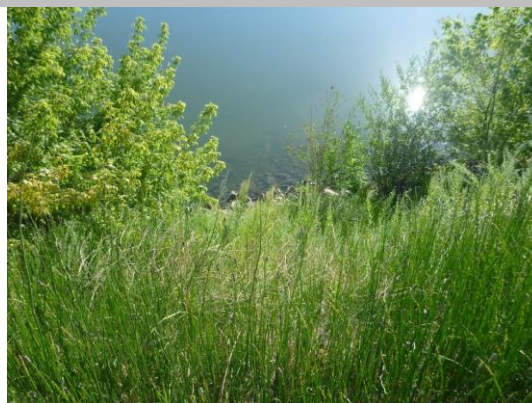
Photo 1 of 2 : FA_2019_RD0003_25_150_20190826_00131.jpg

LM Start	16.54	Rating **	A/W	Issue No.	150
LM End	16.56	Issue Type +	Ma	Location *	WS
Category	Supplemental			GPS Latitude/Longitude	
				Start	End
Item	2017 Storm Damage			38.294717 °	38.294986 °
				-121.565417 °	-121.565661 °
DWR ID	LMA-110				
Comment Code					
Inspector Comment					
Levee Evaluation Comments					
Description:District station 873+61 to 874+83, Sec. 08, T. 5 N. R. 4 E., M.D.M. Approximately 122 linear feet of erosion exists along the water side slope of the Sacramento River (Unit 2). The erosion commences approximately 1/2 of the way down the slope from the crown and extends beyond the rip rap. A section of rip rap has eroded away in this location.					
Site ID No:284					
Site Designation:LMA-110					
Repair Type: Erosion					
Rating:Area of Concern					
Field Date:7/28/2017					
Notes: no berm

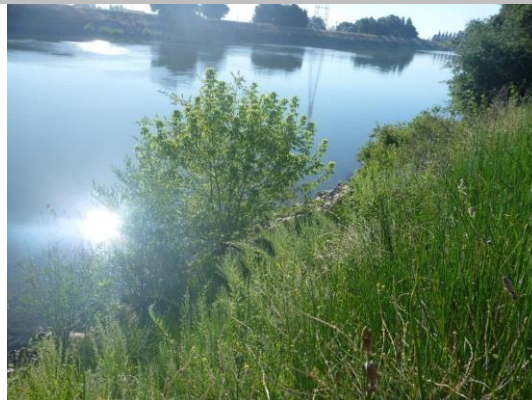
Photo 2 of 2 : FA_2019_RD0003_25_150_20190826_00132.jpg

LM Start	16.54	Rating **	A/W	Issue No.	150 (cont)
LM End	16.56	Issue Type +	Ma	Location *	WS
Category	Supplemental			GPS Latitude/Longitude	
				Start	End
Item	2017 Storm Damage			38.294717 °	38.294986 °
				-121.565417 °	-121.565661 °
DWR ID	LMA-110				
Comment Code					
Inspector Comment					
Levee Evaluation Comments					
Description:District station 873+61 to 874+83, Sec. 08, T. 5 N. R. 4 E., M.D.M. Approximately 122 linear feet of erosion exists along the water side slope of the Sacramento River (Unit 2). The erosion commences approximately 1/2 of the way down the slope from the crown and extends beyond the rip rap. A section of rip rap has eroded away in this location.					
Site ID No:284					
Site Designation:LMA-110					
Repair Type: Erosion					
Rating:Area of Concern					
Field Date:7/28/2017					
Notes: no berm

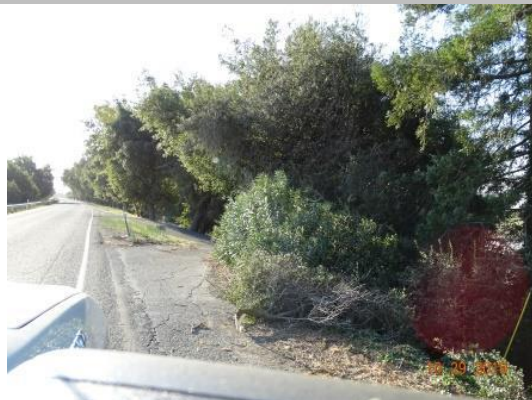
Photo 1 of 1 : FA_2019_RD0003_25_77_20191030_00308.jpg

LM Start	16.59	Rating **	M	Issue No.	77
LM End	16.59	Issue Type +	En	Location *	LS
Category	Earthen Levee			GPS Latitude/Longitude	
				Start	End
Item	Vegetation			38.295183 °	38.295183 °
				-121.566045 °	-121.566045 °
DWR ID	DWR_RD0003_02_s_2012_77				
Comment Code					
V6 : Landscaping					
Inspector Comment					
Landowner removed oleanders, but other vegetation is still blocking the view of the landside slope and toe.

View looking downstream at landscaping on landside slope (Fall 2019).

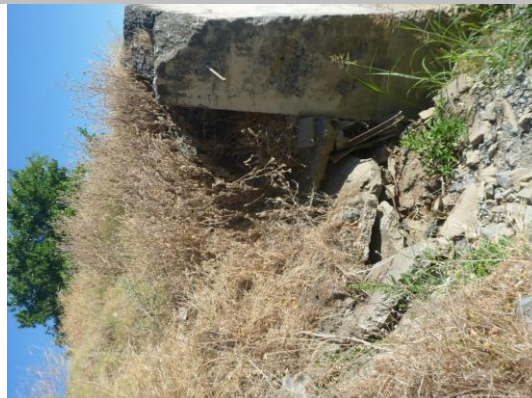
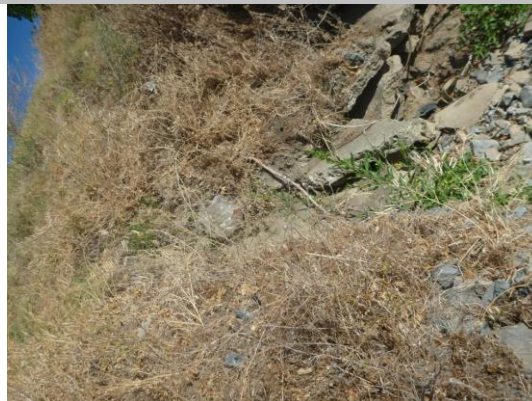
LM Start	16.90	Rating **	A/W	Issue No.	152 (cont)
LM End	16.90	Issue Type +	Ma	Location *	WS
Category	Supplemental			GPS Latitude/Longitude	
				Start	End
Item	2017 Storm Damage			38.298914 °	38.298997 °
				-121.569156 °	-121.569217 °
DWR ID	LMA-111				
Comment Code					
Inspector Comment					
Levee Evaluation Comments					
Description:District station 892+36 to 892+70, Sec. 08, T. 5 N. R. 4 E., M.D.M. Approximately 34 linear feet of erosion exists along the water side slope of the Sacramento River (Unit 2). The erosion commences approximately 1/2 of the way down the slope from the crown and extends into the rip rap. A section of rip rap has eroded away in this location.					
Site ID No:285					
Site Designation:LMA-111					
Repair Type: Erosion					
Rating:Area of Concern					
Field Date:7/28/2017					
Notes: highway on crown

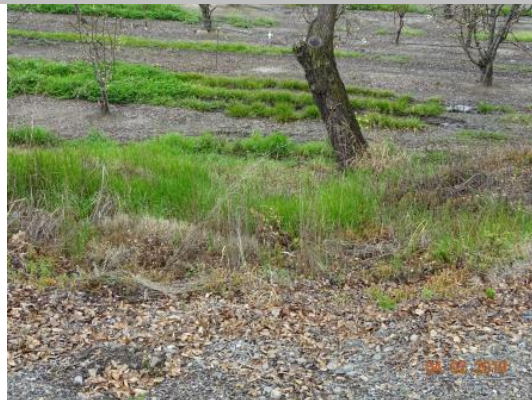
Photo 2 of 2 : FA_2019_RD0003_25_114_20190826_00083.jpg

LM Start	17.27	Rating **	M	Issue No.	114 (cont)	
LM End	17.27	Issue Type +	Ma	Location *	LS	
Category	Earthen Levee			GPS Latitude/Longitude		
				Start		End
Item	Slope Stability			38.303351 °		38.303351 °
				-121.573084 °		-121.573084 °
DWR ID	DWR_RD0003_02_s_2019_114					
Comment Code						
S1 : Repair slope instability.						
Inspector Comment						
There is a depression on the landside slope.

View looking downslope at depression on the landside slope (Spring 2019).
